A Draft Report[®] for the Pilot Demonstration of

Controlled In-Situ Chemical Oxidation Technology

Ashland/Xcel Energy Lakefront Site d.b.a Xcel Energy, a subsidiary of Xcel Energy ("NPSW")

June 1, 2007

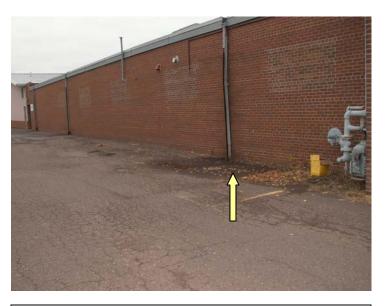
Photo 1 above, taken in July 2006, depicts the **MW-15** pilot demonstration area. The dark depression at the base of the down spout to the left of the gas service (see arrow), reveals the location of the gas holder discovered during the injection activities in November. This area corresponds to the depression in the foundation of the men's lavatory just inside the wall.

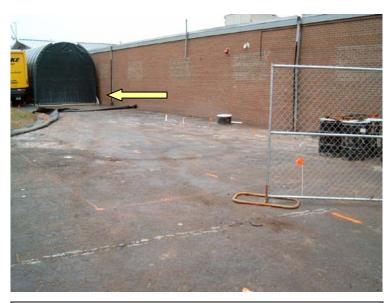
Photo 2 depicts the site undergoing treatment. The green enclosure (see arrow) housed the *Deep-Shot Rig* to protect mixing equipment from the cold and snow.

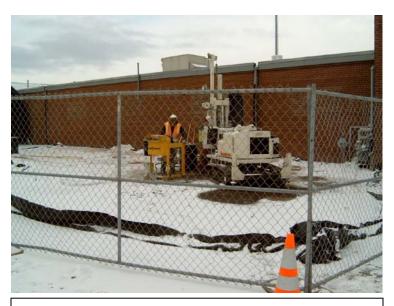
As winter comes to northern Wisconsin **Photo 3** reveals the wisdom of providing heated cover for the pumping equipment.

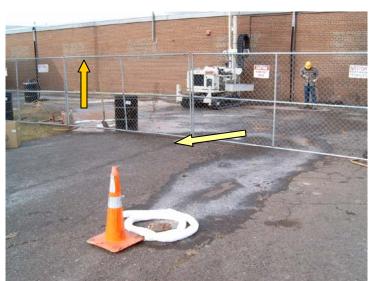
The yellow arrow in **Photo 4** above depicts the location of **MW-16**. The orange arrow shows the location of the soil sampling point where the *Cool-Ox*TM reagent was expelled to the surface. The unreacted white residue and the absence of odor indicate the absence of contaminant

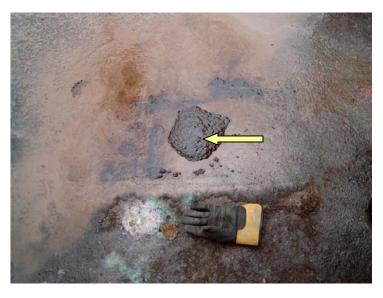
Photo 5 above depicts a contaminant source (**SIB-07** (see **Figure 4**) just outside of the west wall of the holder. Although most of the soil around the holder appeared to be relatively clean, three of the IPs outside of the holder near **SIB-07** exhibited characteristics of significant contamination.

Detecting Contaminant Sources: Photos 5 and 6 graphically demonstrate that the Technology is reacting with contaminants and thus indicating that sources have been located. When these injection points are compared to other IPs such as SIB-15, SIB-2, and SIB-9, where prior sampling confirmed that little or no contamination was present and where no surface reactions for noted, it is evident that the Technology can detect contaminant sources, under the conditions present at this site. It should be pointed out that this feature is a qualitative technique that is useful in characterizing source areas at sites. To some degree, the experienced operator can determine if the sources contains free product or merely adsorbed contaminants. Although, the Process does not provide

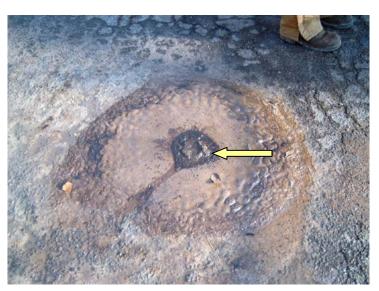
Photo 6 (see arrow) above depicts another location (SIB-16) where a contaminant source was located.

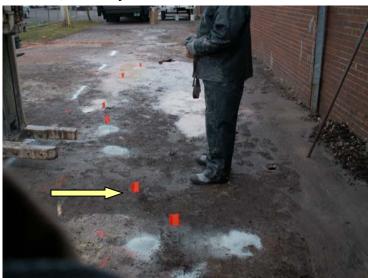
Photo 7 above depicts the location of the holder wall (see flags) revealed by utilizing the probing technique of the DPT rig. The top of the wall was approximately eight (8) fbgs. The holder floor was found to be at eighteen (18) fbgs.

Photos 7 & 8 depict the position of the holder as determined by DPT probing. Subsequent to locating the vessel additional points were determine driven to the relative thickness of the wall. It was found that the wall was approximately one (1) to one and one half $(1\frac{1}{2})$ feet thick and extended from circa eight (8) to eighteen (18) fbgs where the holder floor was encountered. refusal of the type associated with striking concrete was noted, therefore, it appeared that the holder floor was composed of the same type of clay as is present in the Miller Creek Aguitard. This was later confirmed when samples taken from the bottom of the holder during April January and sampling events, contained this type of soil. From an

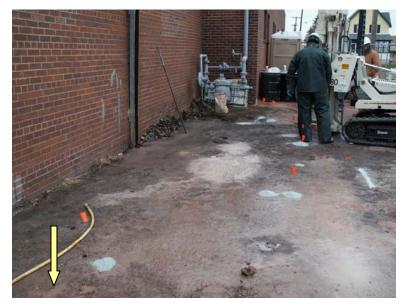
Photo 8 above depicts the location of the holder wall (see flags) from a west to east direction. The arrow indicates the location of the contaminants found outside the holder wall in the shallow (Miller Creek Aquitard). The remainder of the shallow pilot demonstration area outside the holder was relatively free of pollutants.

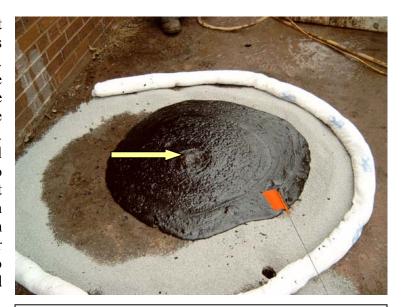
Photo 9 above reveals emulsified coal tar expelled to the surface after reaction with the Cool-OxTM reagent. Note the physical appearance of the material has changed from the sticky, honey-like consistency to that more resembling "cake batter." The edges of the "puddle" show folding and the "rough dull" surface feature is caused by the presence of reaction gasses. The temperature was indicative of groundwater. The slight bump in the middle (see arrow) reveals the IP (**SIB-14**) where the reaction is venting.

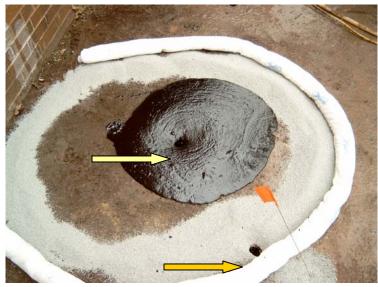
Photo 10 above depicts the reaction as it subsides and the emulsified coal tar runs back down the IP (see yellow arrow) as the reaction pressure subsides. Normally, the IPs are grouted after each injection is completed. However, (SIB-3) (see orange arrow) and some other IPs in the holder were left open to allow venting outside as a precaution because the majority of the holder was located beneath the maintenance building and the TEAM was concerned that vapors would intrude into the building.

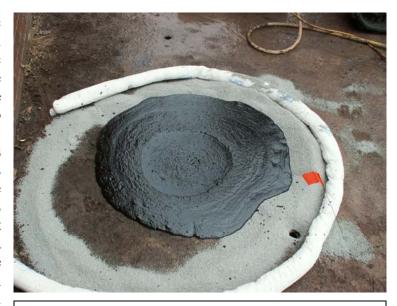
Photo 11 shows the configuration of the emulsified coal tar (ECT) after the reaction has gone to completion and the surface is no longer impacted by subsurface activity. At this stage, the artifact is no longer coal tar but, instead a material that contains a large percentage of water (the transport medium) and reaction gasses. The material smears but, is not sticky or highly odorous like unreacted coal tar.

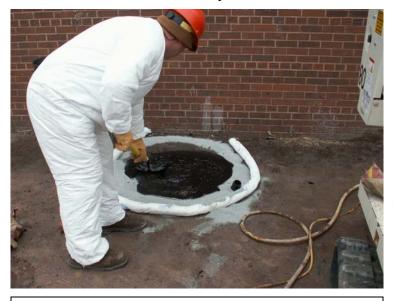
Photo 12 above shows TEAM Site Manager Rick Tolman collecting the ECT for drumming. At this stage, the ECT resembles "pudding" rather than the sticky, honey-like coal tar.

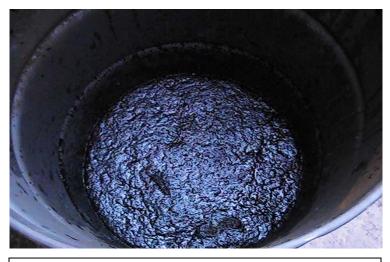
Photo 13 depicts the ECT in a drum. Note the "rough" character of the surface indicative of the reagent reacting with contaminant and generating foam. At this point the physical characteristics of the original product are all but, gone.

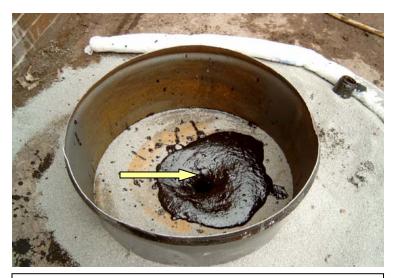
Photo 14 above shows the method used to contain reflections of ECT after the first material had been cleaned up and containerized. This method consisted of placing a cut section of a 55 gallon drum around the active IP and sealing the bottom (inside and outside) with bentonite granules. This effectively allowed the IP (see arrow) to vent while protecting the holder from intrusion by surface water. A drum cover was placed over the top to protect against rain or snow.

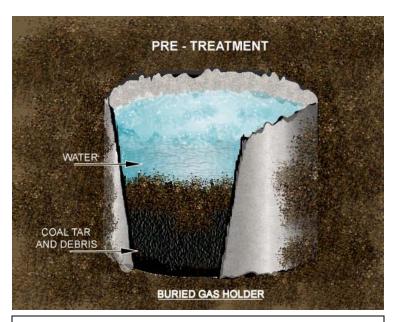
Illustration 1 depicts the suspected configuration of the coal tar/groundwater relationship prior to treatment with the $Cool\text{-}Ox^{TM}$ reagent. Note the water is phase separated from hydrophobic coal tar faction with the heavier tar collected near the lower portion of the vessel. During the injection activities as well as the sampling work, coal tar remnants were observed on the bottom eight (8) feet of the probe rods.

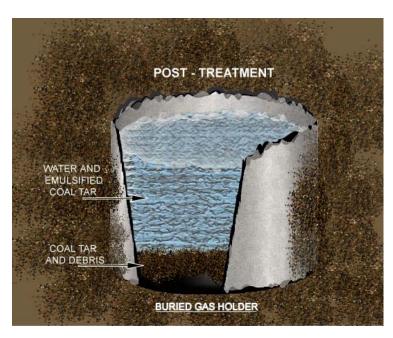
Illustration 2 shows the effect of the oxidation Process as it emulsified the coal tar thereby, increasing its solubility. This also causes the hydrophobic faction to separate and migrate to the heavier molecular weight asphaltene like contaminants in the bottom of the holder. This phenomenon occurs when the concentration or quantity of oxidizer is stoichiometricly insufficient to convert the mass of contaminant to an oxidized byproduct.

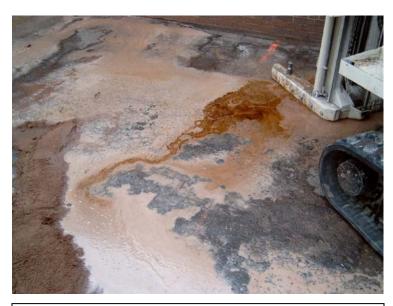
Photo 15 depicts a reflection of contaminant foam from IP-SIB-16. It should be noted that the reagent and a slight amount of contaminant foam can be seen surfacing at the building wall. This indicates that the reagent has reached the foundation and that contaminant was present at this location. This is the area west of the holder near the wall of the maintenance building where contaminant concentrations in the shallow soils were the greatest.

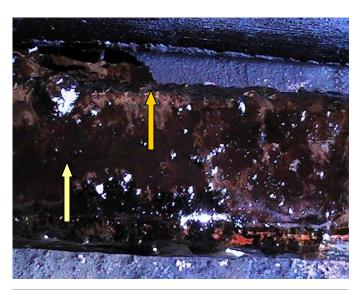
Photo 16 reveals the watery mass of ECT collected at the bottom of the holder during the January sampling event. Note the ECT (yellow arrow) and the soil and reagent mix (orange arrow). Samples collected at this interval prior to treatment were black with no phase separation

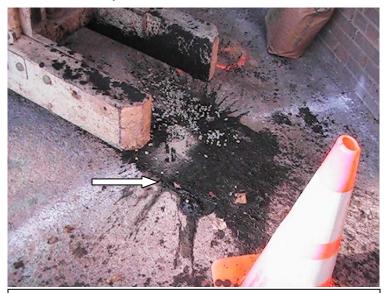
Photo 18 above shows where a "soil" sample was collected during the January 2007 sampling event. This spill occurred when the soil sample collected from the bottom of the holder was so liquefied that the sampling tube was could not contain the soil sample. To retrieve soil samples, the probe was driven into the clay bottom of the holder to form a plug. The holder contents displayed the same watery characteristics during the April 2007 sampling event. This was evidence that the emulsion had not broken since the November treatment.

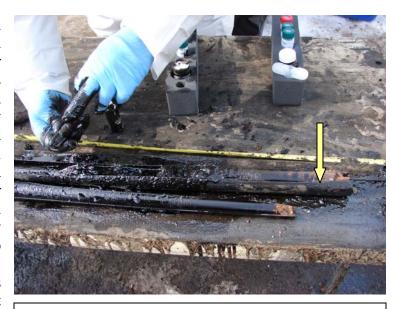
Photo 19 above is additional evidence that of the accumulation of heavy coal tar artifacts at the bottom of the holder. It is expected that these samples will exhibit contaminant concentrations relative to those collected during the January 2007 event. Note the clay plug from the bottom of the holder to the right of the photograph (see arrow).

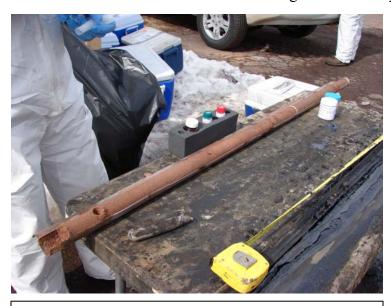
Photo 20 shows a core sample taken outside the holder near **SBN**. Note the reddish color of the soil and the apparent absence of any coal tar artifacts. This core very different in appearance from those collected within the holder. It should be noted that the integrity of the soil allow meaningful samples to be collected from very defined vertical intervals. This was not possible in the holder where the heavy coal tar was desorbed from the soil, cinders (ash) and debris and settled to the bottom of the vessel.

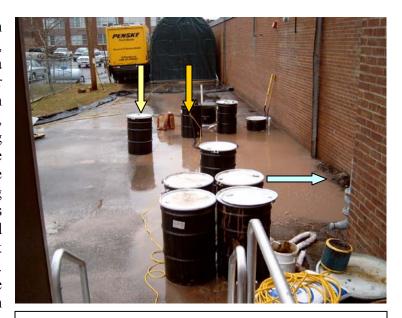
Photo 21 shows rain water that collected in the depression (see Photo 1) over the holder from the roof downspout and the parking lot. The water was contained in the treatment area by the boom (see yellow arrow) placed across the alley. The water was containerized with the drum vacuum (see orange arrow) and disposed of. The soil placed and compacted against the building wall to prohibit vapor intrusion into the men's lavatory in the building, where the foundation had settled can be seen (see blue arrow) at the right of the photo near the downspout.

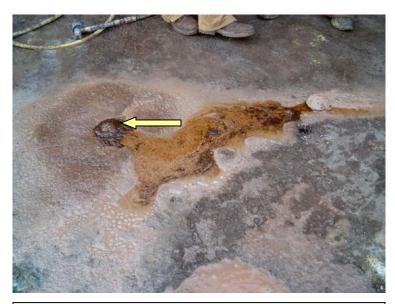
Photo 22 depicts the reflection of coal tar from one of the deep injection points when the probe had been withdrawn. Because the pilot location was not impacted by the Filled Ravine, the threat of cross contamination between the Filled Ravine and Copper Falls Aquifer was greatly reduced. Thus, it was possible to observe contaminants reflected from the Aquifer. All IPs place into the Copper Falls formation were grouted to the surface with portland Cement.

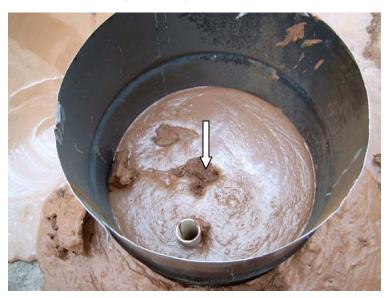
Photo 23 depicts the foam caused by the reaction of the reagent with the contaminant, breaking out around monitoring well **MW-15B** as the reagent is injected at **IP-DIB-13**. Newfields had reported that they believed the integrity of the bentonite well seal had been compromised for some time by the corrosive activity of the coal tar. As the reaction occurred, the foam was contained by the cut drum. The monitoring well is protected by the PVC pipe extension. Expelled material outside the cut drum was collected for disposal and containerized in 17-H, 55 gallon drums.

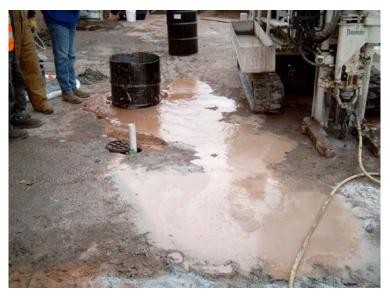
Photo 24 reveals the proximity of **MW-15B** to the holder. Monitoring well **MW-15A** is located in the foreground. **MW-15A** was unaffected during the treatment. **IP-SIB-3** (in the holder) can be seen just behind the person in the blue jeans. Injection point **DIB-13** can be seen in front of the Geoprobe[®].

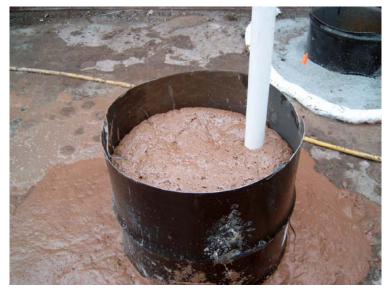
Photo 25 depicts the continuing reaction (note rising foam caused by the emission of carbon dioxide) after injection has ceased at monitoring well **MW-13B** just outside the holder. **IP-SIB-3** inside the holder can be seen at the top right of the photo.

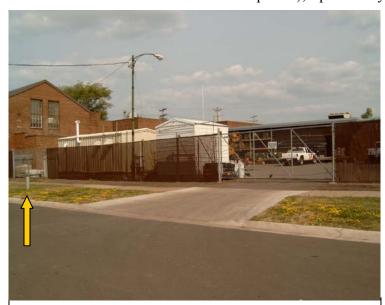
Photo 26 shows the **MW-13** pilot demonstration area prior to treatment in early July 2006. The telephone service near extraction well **E-1** is located to the left of the photo (see arrow).

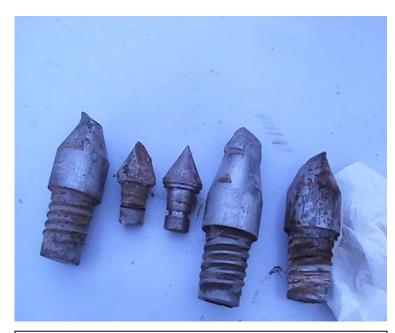
Photo 32 above depicts only a few of the confrontations between the injection probes and the rocks in the Copper Falls Aguifer. The item in the middle is a new, undamaged expendable point. This provides a driving tip for the probe rods. When the probe reaches the desired depth, it is withdrawn two (2) to six (6) inches and the point pushed out by the pressure of the reagent. This initiates the injection Expendable points are used when the process. injection protocol calls for injections to start at the bottom of the vertical injection interval (VII) and distributes the reagent to the top as the probe is withdrawn. This is referred to as bottom-up (BU) delivery. The two items on each end are solid drive points that provide a drive point for retrievable tooling such as the Pressure Activated Valve (PAV), employed when the reagent is distributed from the top of the VI downward. This is called top-down (TD) delivery. All four (4) of the used point exhibit evidence of striking rocks.

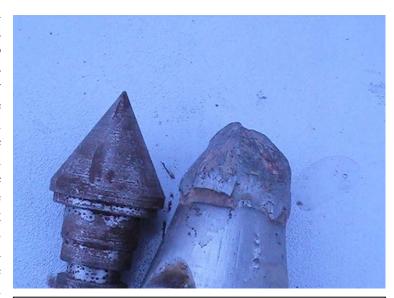
Photo 33 above shows a close-up of an expendable point on the right that has been driven into the point holder with such force that the two parts appear to be welded together. This point was retrieved from **IP-7** near extraction well **E-2**. It can be seen that the point was "peened" on all sides by striking rock. Pump pressure applied at 1,200 psi could not dislodge the point. Prior to the initiation of the injection work, it was believed that the hard clay structure of the Miller Creek Aquitard would provide the greatest test for the driller. It turned out that the cobbles in the Copper Falls Aquifer provided the real challenge. Refusal proved to be so severe that the average depth of penetration was 63.5 feet.

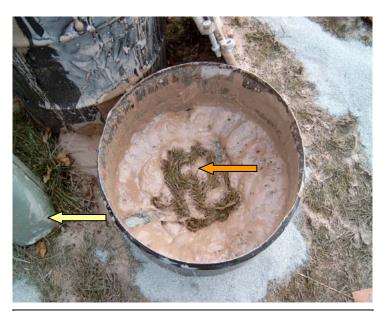
Photo 34 above depicts the volunteer breakout (see orange arrow) near the telephone service (see yellow arrow) where the contaminant reacting with the *Cool-Ox*TM reagent was expelled to the surface through a previous sampling point. This occurred during injection in **IP-1** near extraction well **E-1**. Note, the reaction was contained using the cut drum method that proved successful during the injection work in the **MW-15** pilot area.

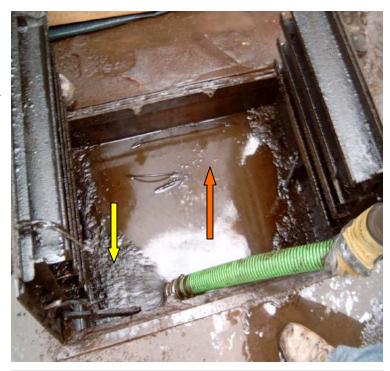
Photo 36 reveals the communication between IP-2 (near E-1) and extraction well E-3 across the site. The force of the reaction gasses raised the water level in E-3 from the Copper Falls Aquifer to above the well casing into the vault. An industrial vacuum is used to aspirate the groundwater and contain it in a tank. The bubbling from the well casing can be seen in the top center of the photo (see orange arrow). Coal tar can be seen floating on the surface (see yellow arrow). At this time, the pH of the groundwater was still at ~6. However, with in one hour of the expulsion, the pH had risen to ~7. Communication from E-1 across the site to E-3 demonstrated that conditions in the Copper Falls Aquifer were conducive to contaminant extraction.

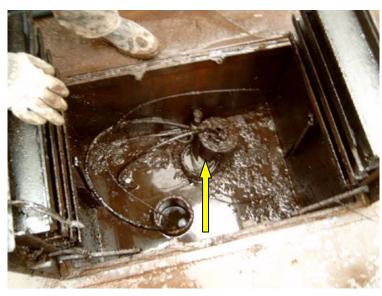
Photo 37 reveals that the color of the groundwater in extraction well **E-3** is changing from a semi-clear appearance to a dark tan, translucent liquid interspersed with globules of coal tar. Note the groundwater has been raised to the top of the casing (see arrow) and the pH is now approximately 7.5.

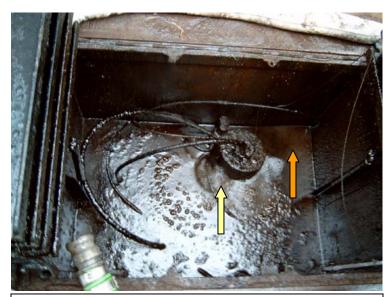
Photo 38 The pH of the groundwater in well vault **E-3** has reached 8, the optimum for the oxidation reaction of the $Cool\text{-}Ox^{\text{TM}}$ process to proceed. The color of the water is now a milky tan (see orange arrow) indicating the presence of emulsified coal tar (ECT). Note the coal tar has broken up to finer globules and foam (see yellow arrow) is now being generated from inside the well casing. The amount of ECT expelled from the well is increasing.

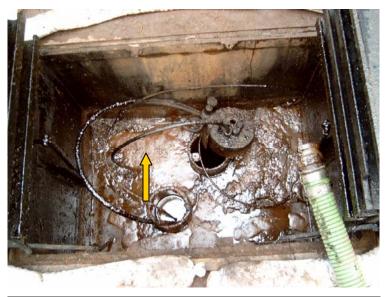
As the groundwater level in **E-3** casing drops, **Photo 39** reveals the ECT left in the vault. Note the foam (see arrow) generated as the oxidation reaction proceeds.

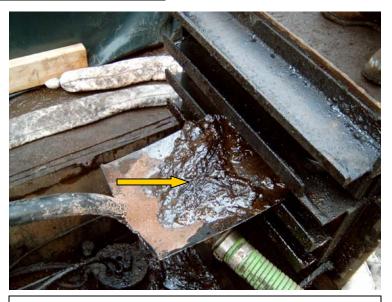
Photo 40 reveals the ECT grease-like material (see arrow) that was expelled from **E-3** by the reaction occurring in the Copper Falls Aquifer. As the globules of ETC were ejected into the vault, they settled to the bottom and congealed into the gelatinous material shown on the shovel. The material was containerized for disposal.

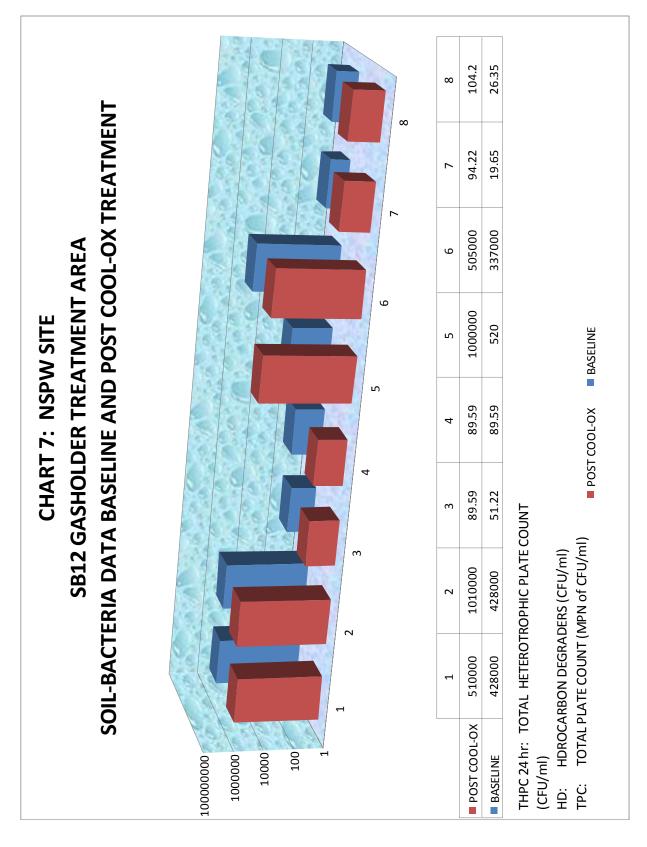
- 5. Chart 7 displays the results provided for soil boring SB-12, which was in the gas holder. The biologic data for the soil does not show dramatic increases for the parameter analyzed (24 and 48 hour THPC, HD, and TPC) as was noted in the groundwater. However, the soil results do indicate that the biologic activity was still present in the soil and that it had not been inhibited by the treatment. This was observed even though most of the contaminants were present in the soil and the chemical oxidants had obviously reacted strongly with the heavily contaminated soil. Therefore, it is believed that the data demonstrates that the biologic activity is still ongoing and the biota are viable and are contributing to the reduction of contaminants in the soil even under such extremely difficult conditions. As the mass of contaminants are converted oxidatively to less toxic and more biodegradable molecules, the biologic activity should be sustained and will likely increase even in this soil providing sufficient nutrients, moisture and oxygen are available.

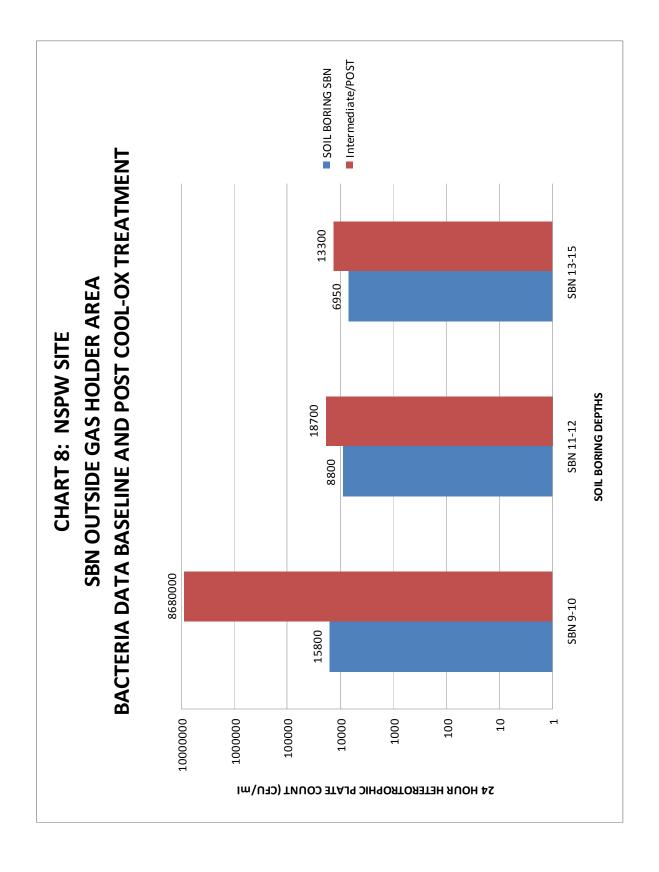
Chart 8

- 6. **Chart 8** displays slightly more promising results for the biologic activity in the soil. It appears that subsurface conditions were more favorable for biologic activity in the area outside of the former gas holder after the *Cool-Ox*TM treatment was performed. This occurred between October 2006 and

January 2007. It appears that biologic activity increased following the treatment performed in the **SBN** area. A dramatic increase in the Total Heterotrophic Plate Count (THPC) was noted at a depth of nine (9) to ten (10) fbgs. Significant increases were also noted at the eleven (11) to twelve (12) fbgs and the thirteen (13) to (15) fbgs sampling locations. The increases were so dramatic that the vertical axis (24 hour Heterotrophic Plate Count) had to be logarithmically presented. Based upon the historical bio-inactivity in this location it no doubt occurred because of the treatment performed in and around the holder.
